Manhole Inspection Summary

Manhole # S19C__015MH

Insp Date: **10/15/07 9:39 AM**

Location Address: **500 PULASKI ST**

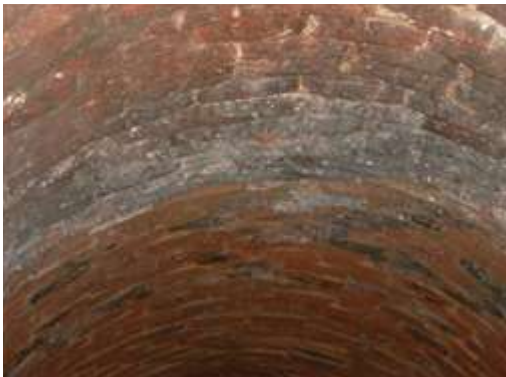
Defect 4

☒ **Evidence Of Surcharge** Depth: **4** (ft.) ☐ Active Surcharge Present

SURCHARGE EVIDENCE ON WALL

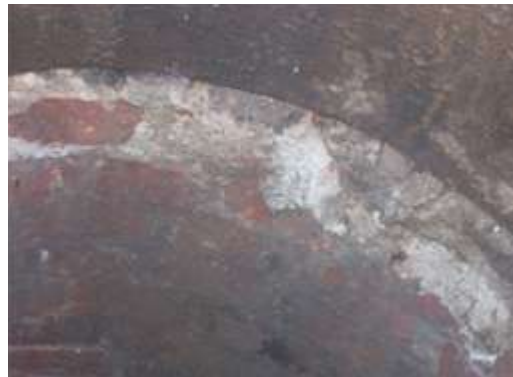
Defect 3

Condition: ☐ Sound ☐ Cracked ☐ Root Intrusion ☐ Loose Brick ☒ **Deteriorated**

CHIMNEY DETERIORATION

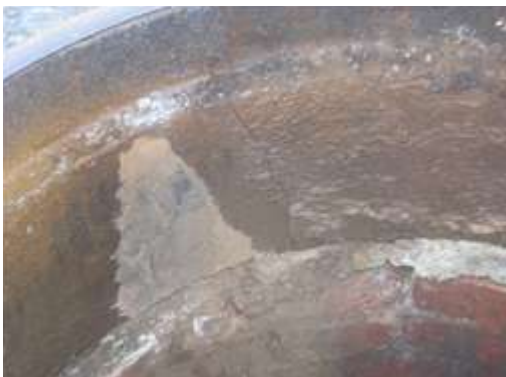
Defect 2

Condition: ☐ Sound ☒ **Cracked** ☐ Leaks

CRACKED FRAME

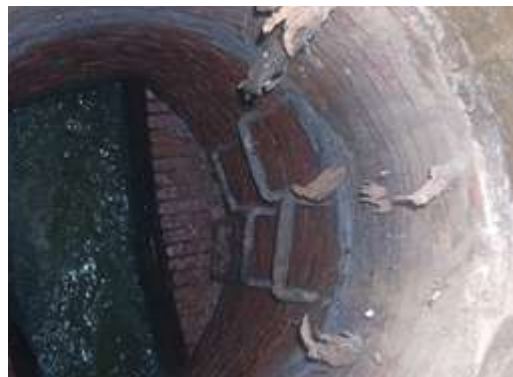
Defect 1

Count: **5** Missing: **3** ☒ **Corroded**

MISSING AND CORRODED STEPS

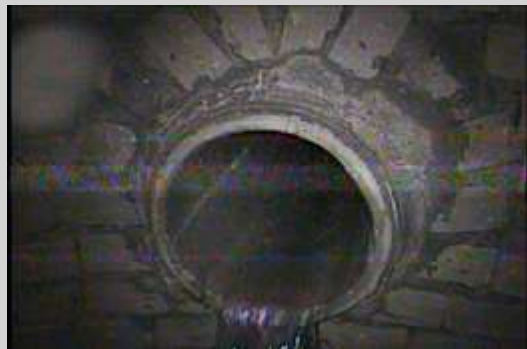
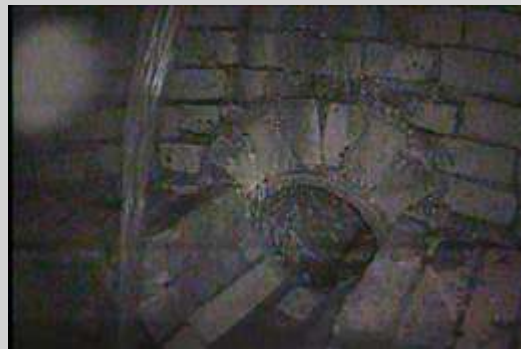
9 O'Clock Inflow

Drop Condition: **Clogged**
